Stabilization of Road Slope failure by Soil Nailing Technique with Shotcrete Frame: A Case Study of Right Bank Slope at Telegangchu Bridge Construction Project, Trongsa

Abstract: Soil nailing is a relatively young concept in Bhutan with not many slides in the country using it as a stabilization measure. The landslide in the right bank slope of Telegangchu bridge project is one of the locations where soil nailing along with grouting and shotcrete frame (200mmx200mm) was implemented. Disturbance in the original slope by excavation, increase in gradient and increase in ground water caused the failure of slope. Conventional methods of stabilization failed to contain the slope after which soil nailing with frame was adopted with proper drainage. The stabilization method proved to be highly effective with drainage playing the vital role in the whole structure's efficiency. This case study and findings paves a way for such strategies to be implemented in similar terrains and soil conditions in Bhutan where conventional methods have failed.

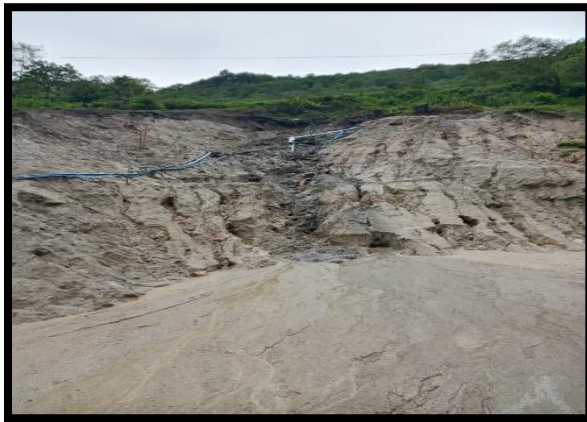
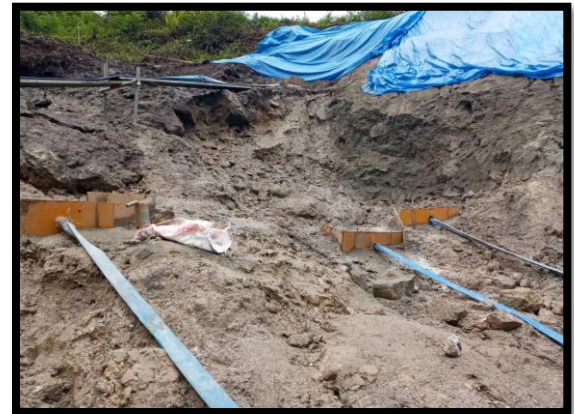
As of September 2020, the whole landslide was a marshy area due to discreet water sources originating from every part of the slope randomly. The colluvium deposits carried to the road side plains spread in a fan shape clearly depicting silty sand(SM) soil type. Manual as well as excavation using backhoe was carried out to remove all the loose deposits and to prevent further wash away, wooden catch basin and water diversion work was done(as depicted in Figure 3).

Figure 3. (a) Fan-Shaped colluvium material deposit at the base of the slope; (b) Water diversion using wooden catch basin

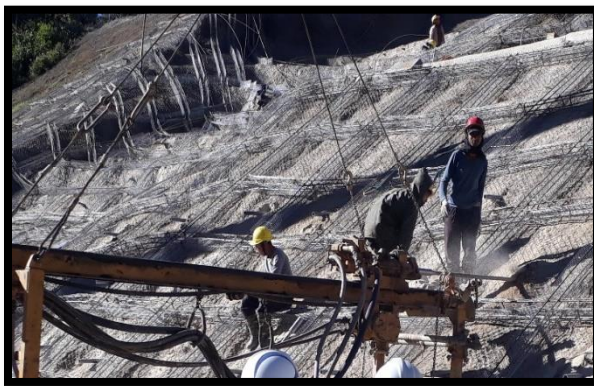
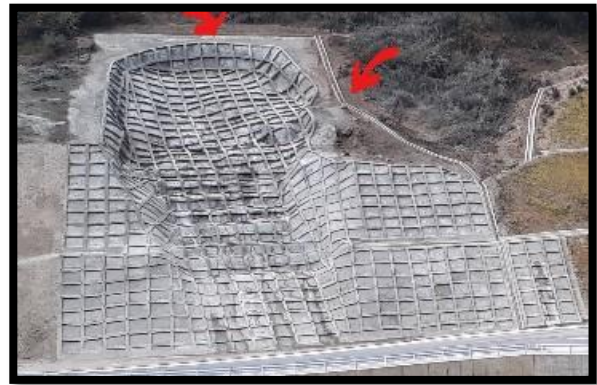
As a remedial measure, total of 452 numbers of 3m long perforated pipes were inserted inside the predrilled hole of 1.5 m x 1.5 m concrete frame covering the whole slope of the frame structure to improve the natural drainage system of the slope (refer Figure 7. (a)). This helped in reducing the uplift pore pressure. An average of 1.7 m width was covered with 10cm shotcrete above the crest of the slope to further prevent penetration of any precipitation. Peripheral drainage gutter of 300mm x 300mm was provided to collect the surface water and divert it away from the slope as shown in Figure 7. (b).

Figure 7. (a) Drilling being done for installation of subsurface drainage; (b) Completion of installation of drain pipes for subsurface, periphery drainage gutter and completion of shotcrete work
