Status of Occupational Health and Safety in Bridge Construction

This paper discusses the status of Occupational Health and Safety in the construction sector particularly in bridge construction works. It highlights the safety guidelines and checklists developed by Japanese experts in collaboration with Bridge Division, Department of Roads. The content of the safety control checklist has been comprehensively elaborated. A comparative case study with regard to standard of OHS administered, between Wangchu Zam construction in Thimphu (carried out by CDCL) and Dangdung and Yurmung bridge construction in Trongsa (carried out by Lamnekha Construction Pvt. Ltd.) has been presented. The study was conducted based on observations made against the requirements specified in the safety control guidelines.

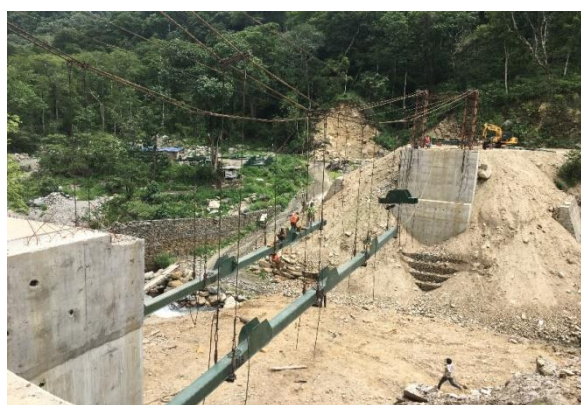
Figure 1: Comparison of working conditions between Dangdung Bridge and Wangchu Bridge. (a) Workers at launching of steel girders without safety belt and PPEs. (b) Quality check/audit at Wangchu Bridge with workers in proper PPEs
