**Gross National Happiness Journal of  
Construction Technology and  
Management**

**No. 2 (2021)**

Construction Development Board

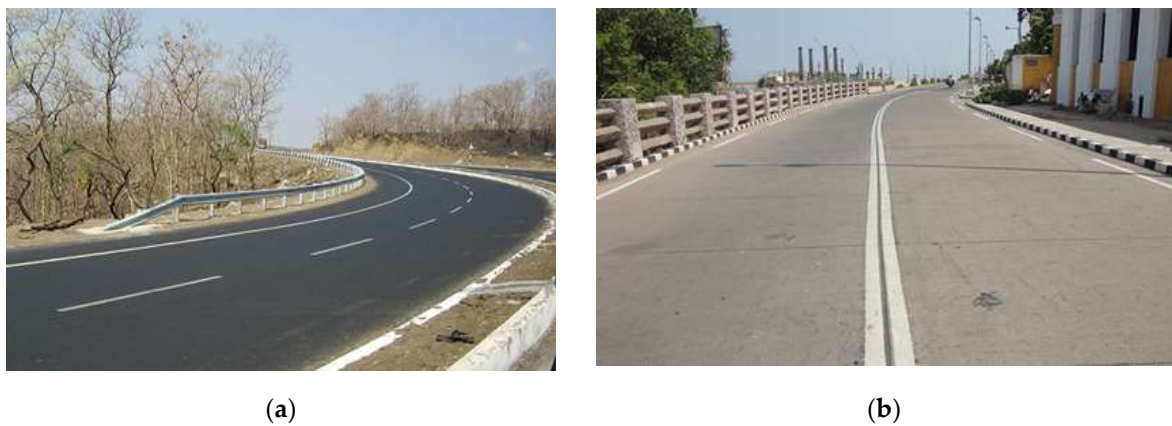
**Figure 1.** Types of road pavement (a) Flexible pavement-asphalt concrete; (b) Rigid pavement-cement concrete (Picture courtesy: [www.nbmcw.com](http://www.nbmcw.com))

Flexible and rigid pavements are typically laid for roads and are most common (Figure 1). A flexible pavement comprises properly heated, mixed and compacted layers of bitumen and a mixture of aggregates laid on a bed of granular layer resting on the prepared natural soil base known as the "subgrade". In the country, rigid pavement is composed of cement concrete or reinforced concrete slab which is laid on dry lean concrete (DLC) base or soil subgrade that is well compacted as per the specification. In some cases, both layers are required when the strength of the sub-base is very low. Sub-base, base course and bituminous surface layer form the overall thickness of the pavement.

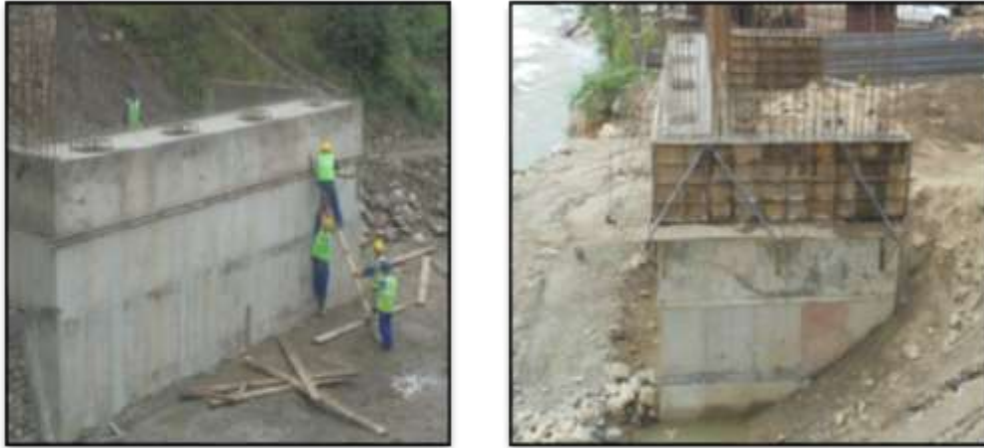
**Figure 9:** Construction of Abutments

The portion of the bridge that supports the superstructure and distributes all bridge loads to bridge footings is substructure. The substructure was inverted T-type abutments which were restrained by wing walls. The height of abutment was 10m. The Figure 9 shows the construction of abutments.

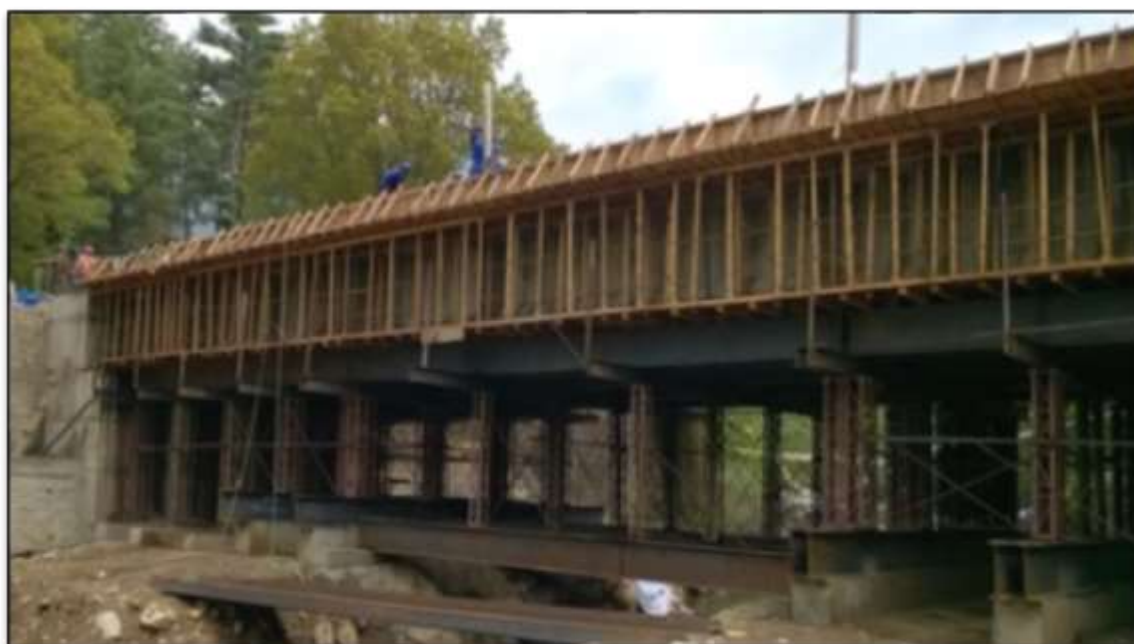
**Figure 10:** Staging for construction of superstructure

Staging is a temporary structure usually of timber and steel erected to support the construction of superstructure of the bridge. If the flow of the water is in reasonable limits, the staging may be designed in beam or arch types with footings on water. Some superstructure design such as steel trusses girder and prefabricated reinforced concrete girder do not require staging. In fast flowing rivers or deep gorges where it is not possible to build staging, the form traveller is preferred. In the case of Dechencholing bridge, the precast girder was not possible due to lack of working space. A steel staging was design and built to construct superstructure. The Figure 10 shows the staging erected for construction of superstructure.

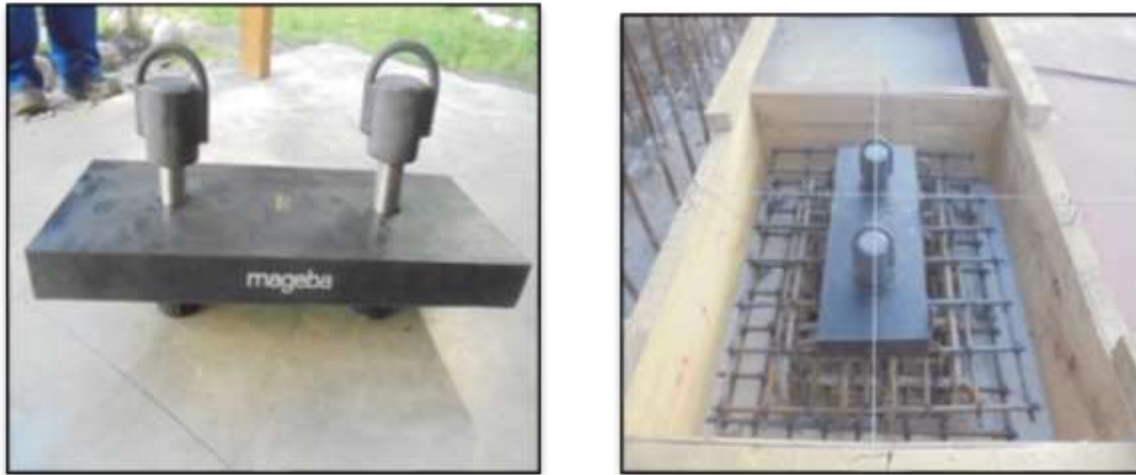
**Figure 11:** Bearing placement on abutment

A bridge bearing is a component of a bridge that is placed between bridge piers and the bridge deck. The bearing carries both vertical and horizontal load of superstructure and transfers to bridge substructure. The elastomeric bearings were designed and used. The bearing is made with a steel plates bonded to the rubber through a vulcanization process to increase the resistance of the bearings to vertical loads and deformation in any direction. The bearings for Dechencholing bridge were manufactured at Mageba Limited, India. The bearing was design based on the AASHTO LRFD, 7<sup>th</sup> Edition, Method B, Steel Reinforced Elastomeric Bearings, section 17.7.5. The bearing on the left abutment was fixed and on the right abutment was free. The bearing was design with shear modulus of elastomer in the range of 1-1.3MPa with minimum yield strength of steel as  $f_y=240\text{Mpa}$ . The Figure 11 shows the bearing installation on abutments.

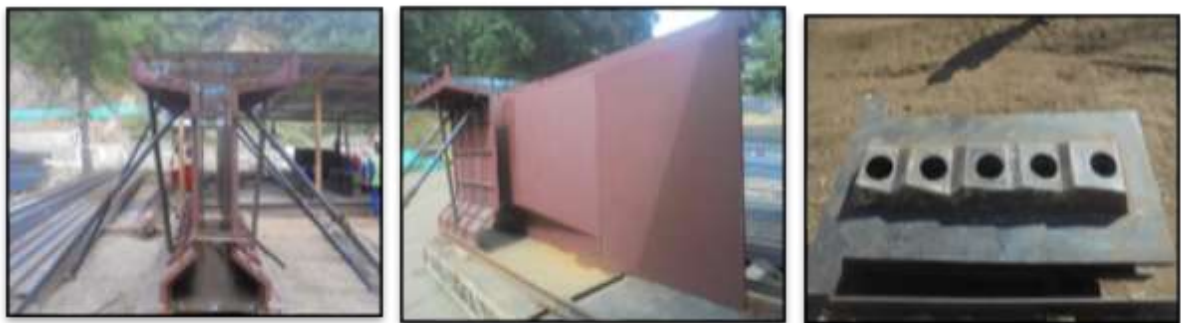
**Figure 12:** Fabrication of shutter for longitudinal girder (mid-section, transit and end shutter)

The superstructure of the bridge consists of longitudinal girder, cross girder, seismic arrestor block, deck slab, connecting slab, kerb beam and railing post. As per design four numbers of I-shaped longitudinal girder were constructed. Each girder was 1.78m depth. The longitudinal girders were RCC prestress and post tensioned with 12-T-13. The longitudinal girders were interconnected by four RCC cross girders placed at an interval of 9.7m c/c. The Figure 12,13 and 14 shows the sequence of longitudinal girder casting.

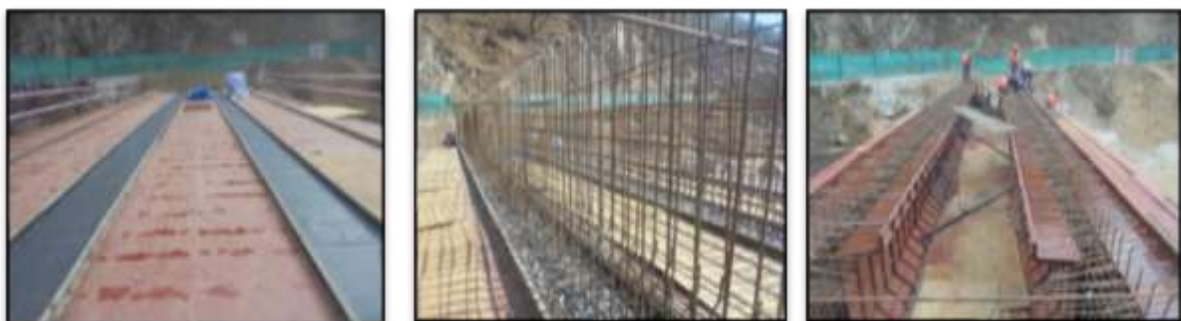
**Figure 13:** Fixing of platform, reinforcement bar and shutter for longitudinal girder casting

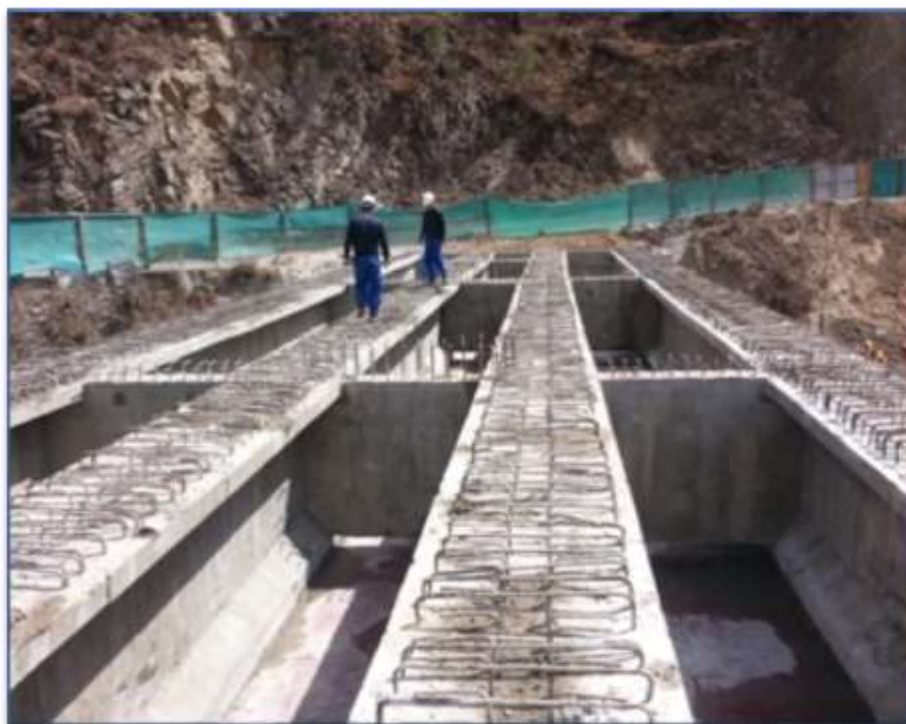
**Figure 14:** Casting of longitudinal girder and cross girder

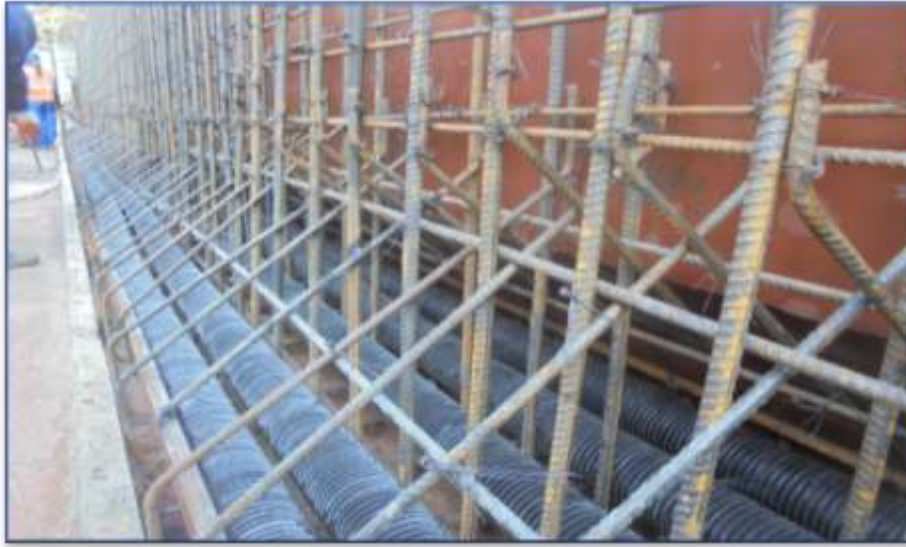
**Figure 15:** Tendon layout profile in longitudinal girder

tendon profile was laid in a smooth parabolic curve between specified control points. The Figure 15 shows the tendon layout profile.

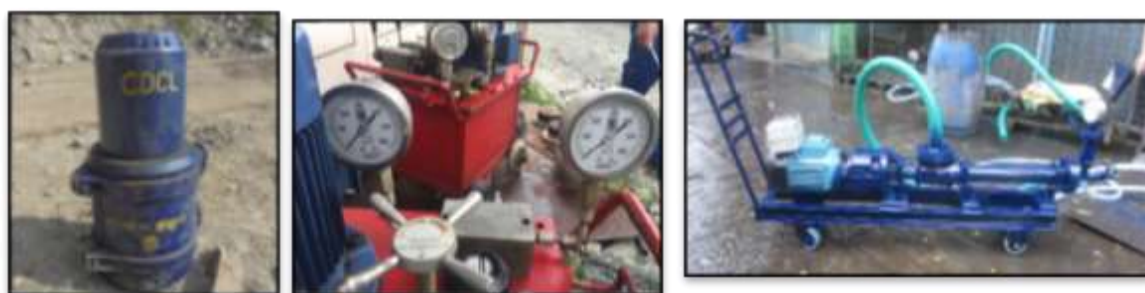
**Figure 17:** Post tensioning equipment (stressing jack, pressure pump, grouting pump).

The Figure 17 shows the post tensioning equipment (stressing jack, pressure pump, grouting pump).

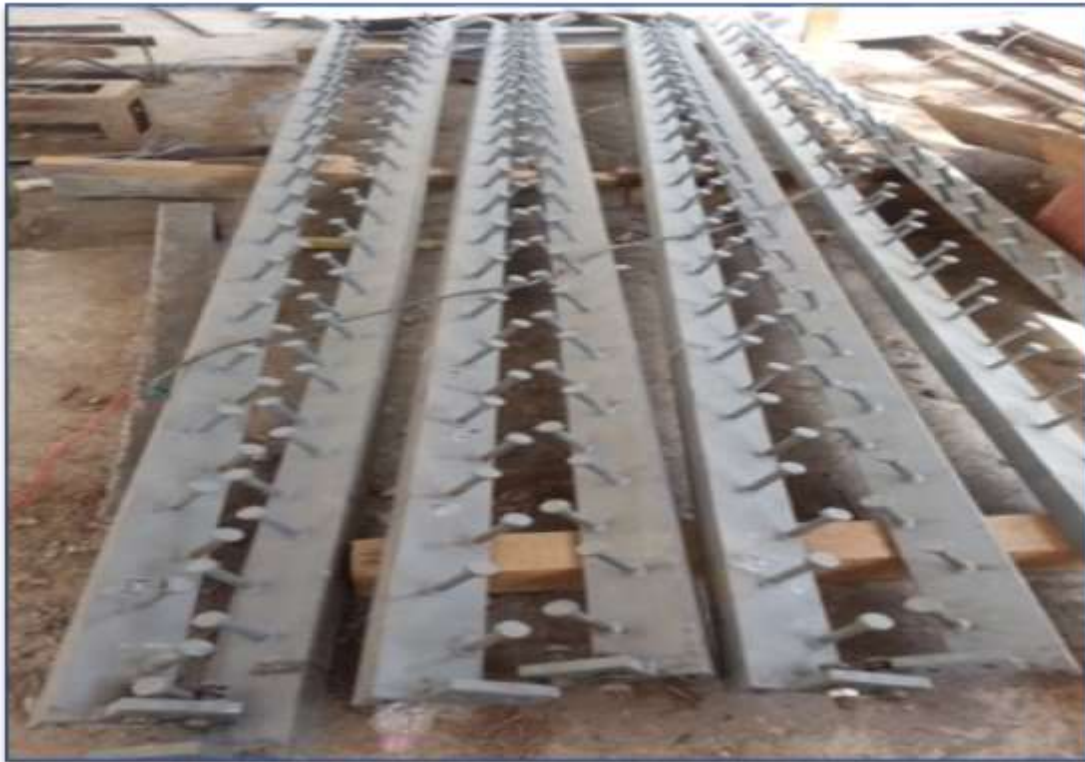
**Figure 18:** Strip seal expansion joint.

To cater for the expansion and contraction of superstructure, TENSA-GRIP Strip Seal Expansion Joint, Type RS-B80 (loop anchorage) with max moving capacity  $\pm 40\text{mm}$  from Mageba India was provided. The steel for edge beams was conform to the steel grade corresponding to ASTM A36 (A low-carbon steel with excellent fabrication properties) or Canadian Standards Association (CSA) standard G40.21 Grade 300W (This grade is utilized in general fabrication and construction. It also referred to as 300W, which is its metric designation). The edge beam was anchored to the deck by reinforcing bars cast in concrete. The anchorage steel was conformed to IS: 2062. The steel sections were protected against corrosion by hot dip galvanizing coating with a minimum thickness of 100 micron. The Figure 18 shows the strip seal expansion joint.

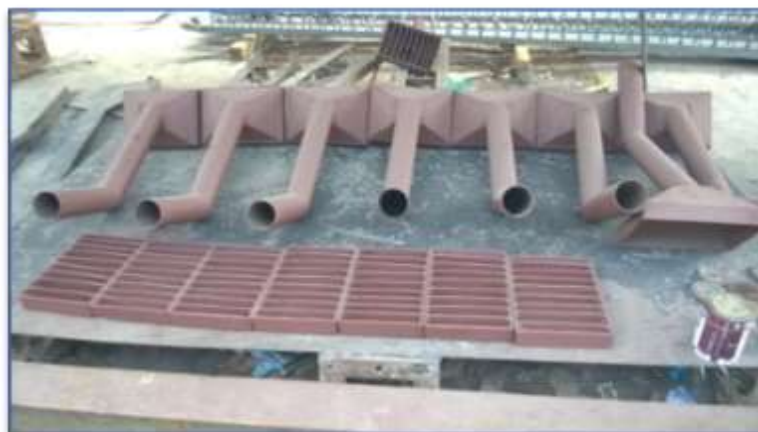
**Figure 19:** Drainage spouts.

Waterspouts was required to drain out the rainwater from the deck surface quickly. The deck camber helps the rainwater to drain quickly towards kerb. The waterspouts located near the kerb further disposes the water out. One waterspout per 20 sq.m. of the deck area was installed. The drainage spot was fabricated at site. The Figure 19 shows the fabricated drainage spouts at site.

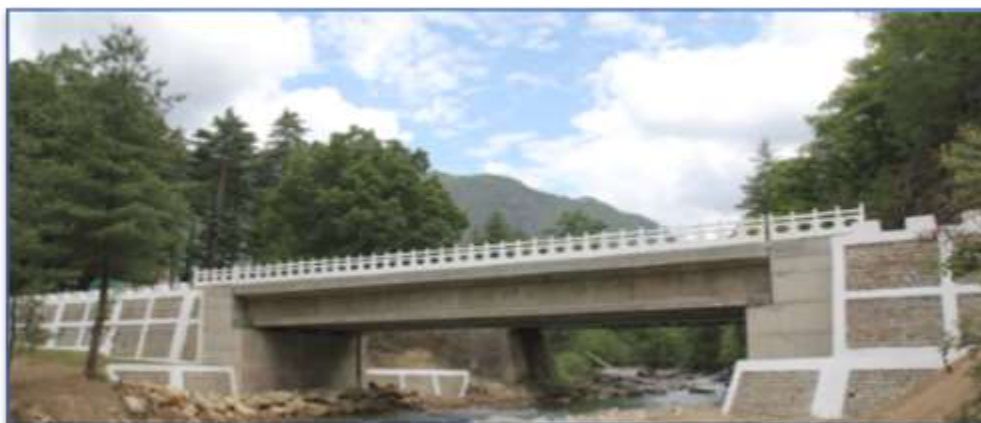
**Figure 20:** Completed bridge

The bridge construction took 14 months with additional 2 months for design. The bridge was completed on 20<sup>th</sup> May 2016 and handed over to Thimphu city. The Honorable Prime Minister of Bhutan inaugurated the bridge on 10<sup>th</sup> June 2016. The Figure 20 shows completed bridge.

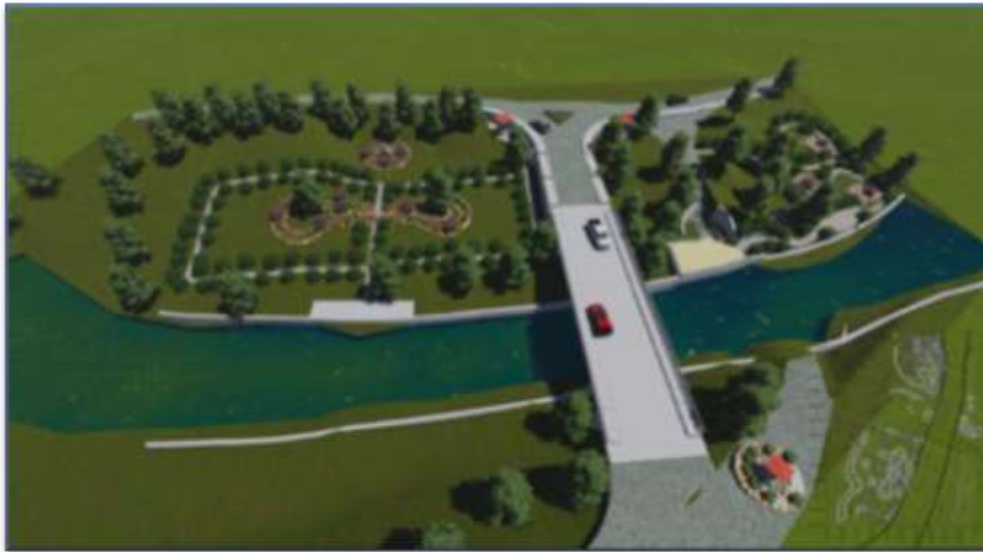
**Figure 21:** Proposed landscaping of bridge site.

The site development works includes river protection and landscaping works. The river protection work was accorded priority over landscaping due to limited budget. However, the bridge being within the vicinity of city and Royal palace, the landscaping is proposed as shown in Figure 21 to improve the aesthetic of the bridge. The Thimphu city plans to take up landscaping work in the future.

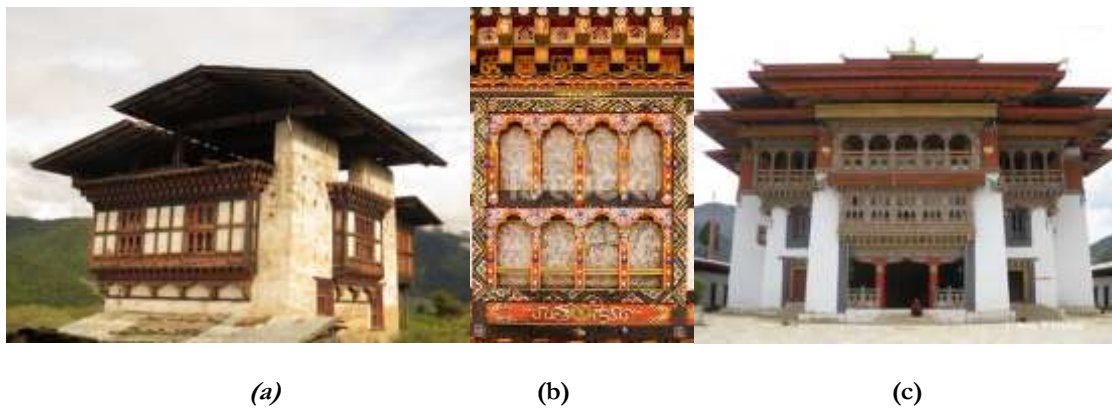
**Figure 4.**(a) & (b) Traditional lime paintings at Phobjikha. (c)Overhang technique in Gangtey Goenpa. Picture courtesy Dawa

People of Phobjikha use traditional painting over wooden Rabsel which is the trend in the society. The main purpose of using paintings is to enhance the aesthetics of building and to preserve the traditional painting cultures. In one way or other, when buildings of Bhutan which are mainly composed of wooden frames like Rabsel are covered by traditional paintings, it also increased the life span of structure and protects from the fire. The materials used in Bhutanese paint are the natural pigmented soils that are found throughout the country. These natural soil pigments are of different colors and are named accordingly. The black lumps of soil are known as ‘*sa na*’, and red lumps as ‘*Tsag sa*’, (Zorig Chusum, 2002). Some area in Bhutan uses lime as paintings to enhance their dwellings and to preserve the wood used in the structures. The limestone and other natural paintings used in Bhutanese architecture acts as a prevention method for outbreak of fire.

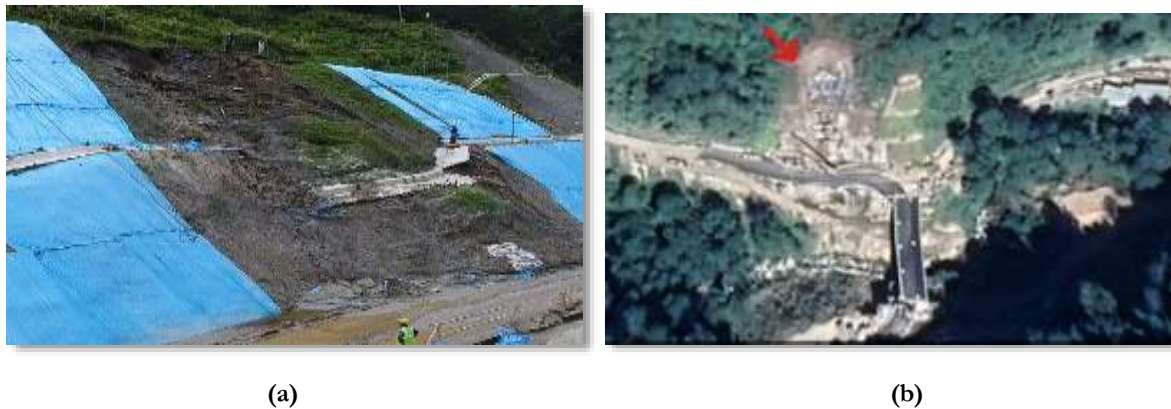
**Figure 2.** (a) Aerial view of the slide area (Source: Google Earth); (b) Right bank slope after initial slide

The right slope of the bridge abutment was excavated in a slope angle of 1:1.2 and bio-engineering was initially planned as the stabilization method which will not be discussed in this paper. With the onset of monsoon slight crack 18m above the road level was observed. The first crack was approximately 50 cm which was visually observed by the site engineer. This crack gradually broadened due to continuous precipitation, resulting in a rotational slide. As a temporary measure, tarpaulin sheets were used to cover the crest of the slope failure to prevent further seepage of water into the soil.

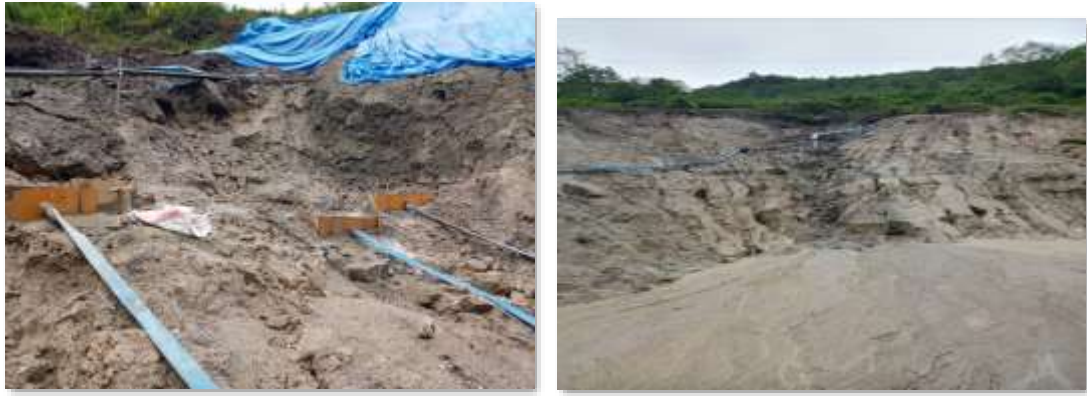
**Figure 3.** (a) Fan-Shaped colluviums material deposit at the base of the slope; (b) Water diversion using wooden catch basin

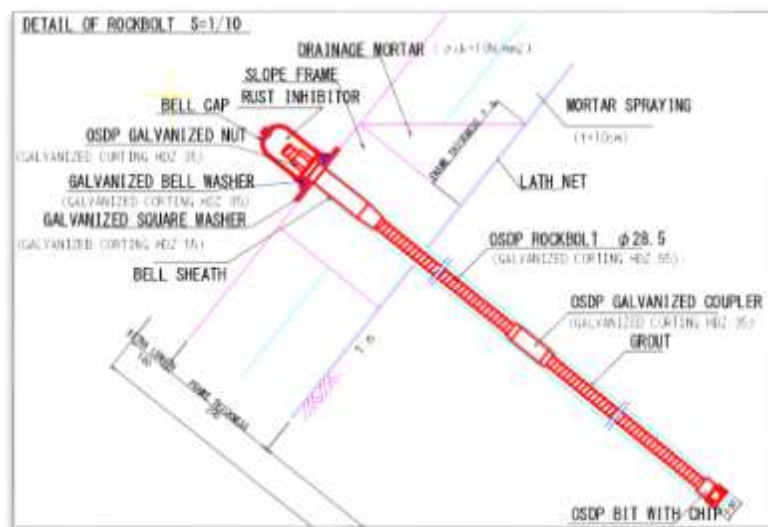
**Figure 4.** Detail of Soil Nailing Component

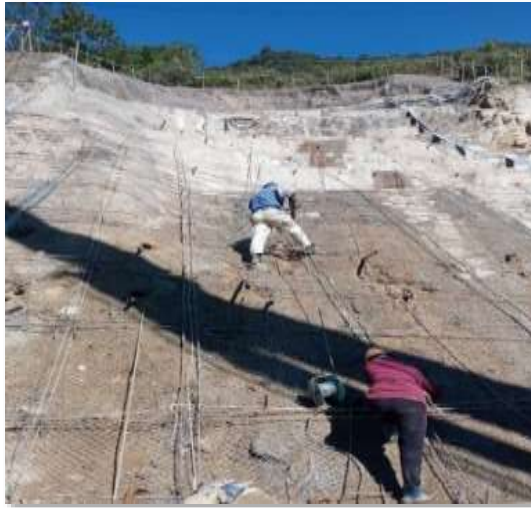
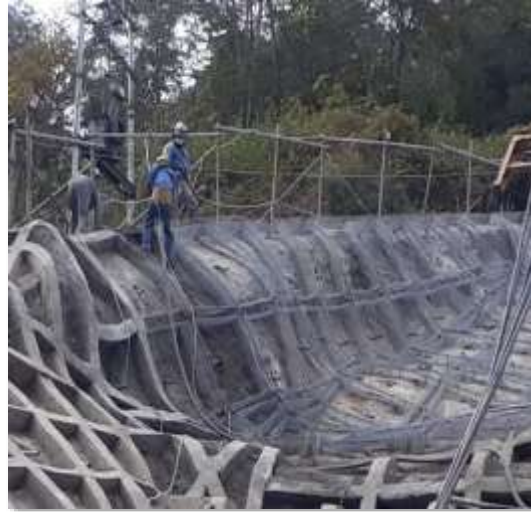
**Figure 6.** (a) Installation of Rebar and Anchors; (b) Mortar spray of the slope frame

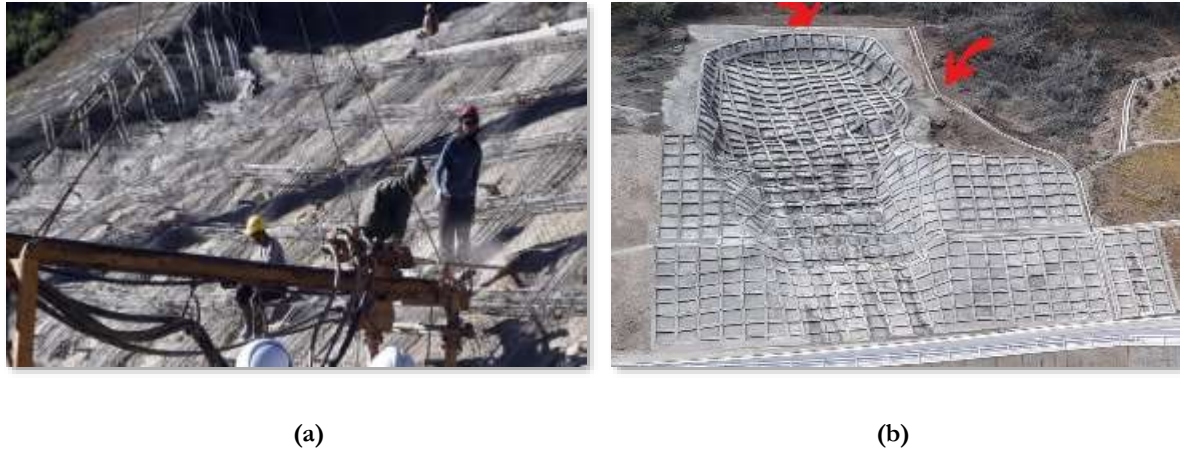
**Figure 7.** (a) Drilling being done for installation of subsurface drainage; (b) Completion of installation of drain pipes for subsurface, periphery drainage gutter and completion of shotcrete work

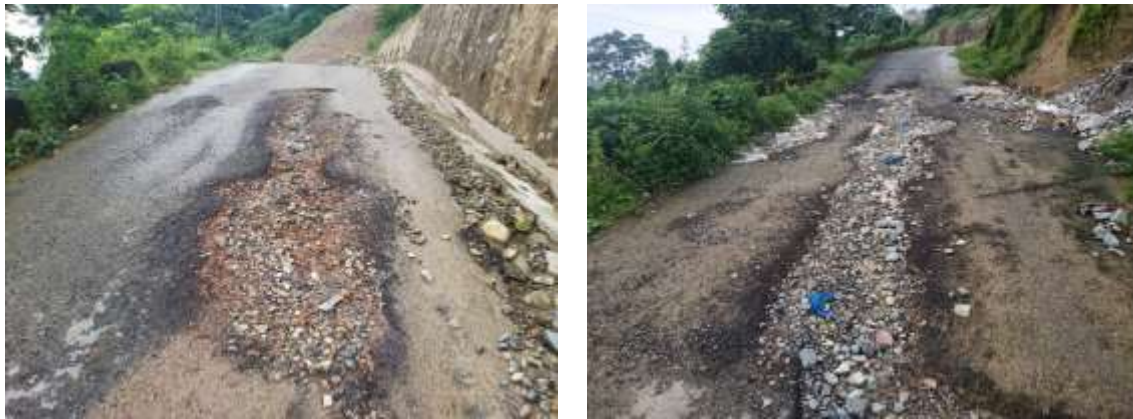
**Figure 3.** Post condition of pavement surface due to poor base materials

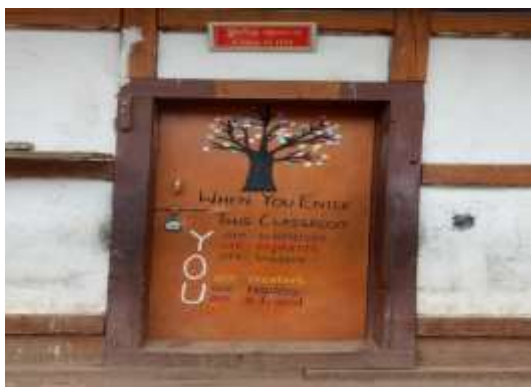
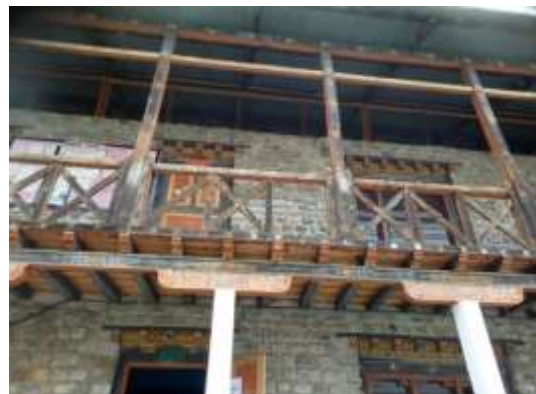
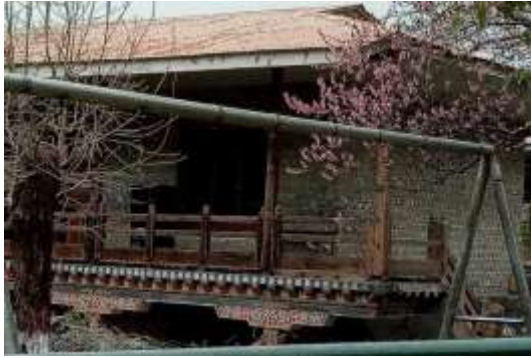
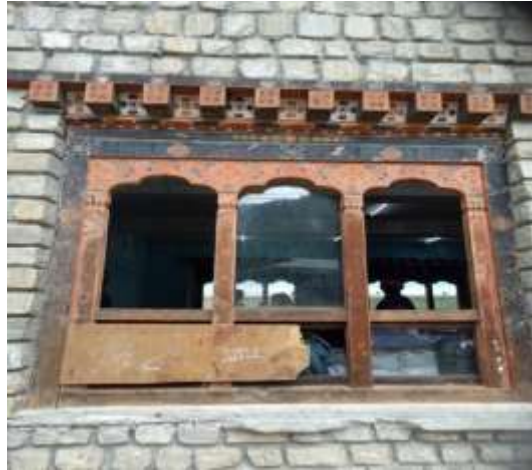
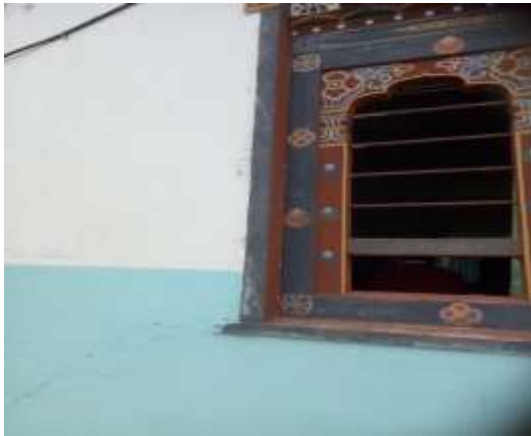
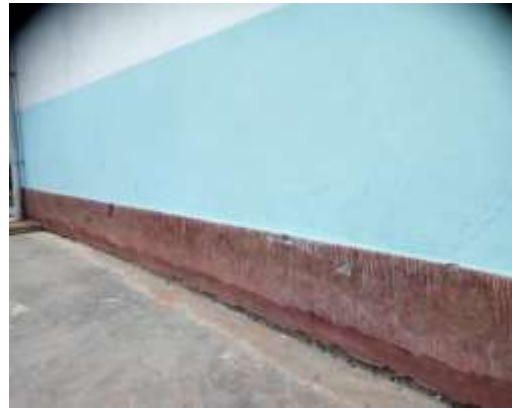
**Figure 1.** School building infrastructure

The infrastructure such as broken windows, door, floor, rallying and crack walls in the observed schools required immediate maintenance. According to the MoE (2016, p.11) argue that "the maintenance and improvement of the school buildings, property and grounds, education materials and equipment are crucial. The safety and security of the school properties must be insured" to foster healthy learning and growth. The school infrastructures were not seismic resilient, user-friendly, and of high quality with space for academic, technology, physical, social and emotional development of teachers and students. School or classrooms are the second home for teachers and students where they spent more than six hours in a day interacting with each other.

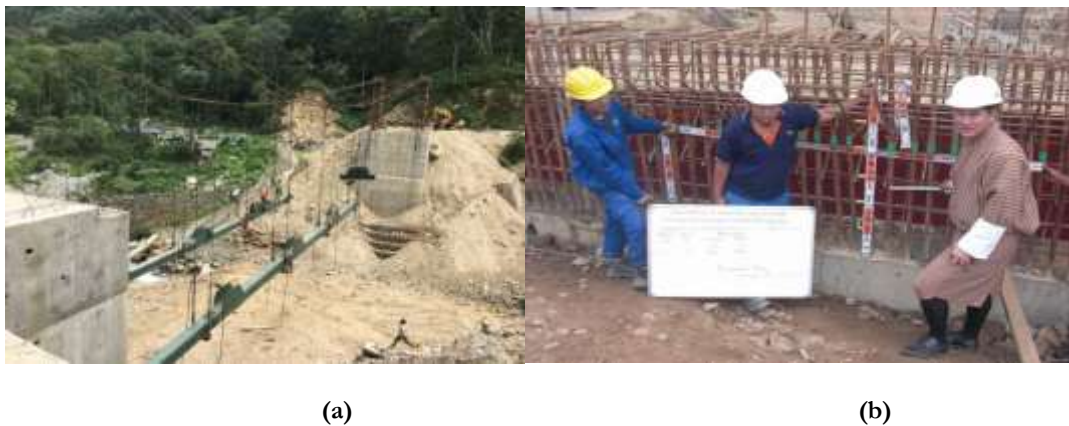
**Figure 5:** Comparison of working conditions between Dangdung Bridge and Dechen Bridge. (a) Workers at launching of steel girders without safety belt and PPEs. (b) Quality check/audit at Dechen Bridge with workers in proper PPEs.

| 11 | Shoring works | For shoring works, 4 temporary concrete frames were built on the river bed. Wooden planks were placed across these frames and shoring metal poles raised upon them. Designed shoring arrangement was used with proper metal clamps. Walking platforms were provided by laying wooden planks across the openings. Workers used safety harnesses while working on the structure. However, when dismantling, it was observed that the workers threw the shoring poles carelessly from where they were detached into the flowing water below. | During the launching of steel truss girders, no shoring structure was built to support the girders. Instead, tension steel wires were stretched over the steel towers at each abutment and anchored to heavy weights. The girders were then suspended by means of wires and launched across after fixing the connections. During the launching, the workers were seen without safety helmets and safety harnesses. |
